CITY OF BALTIMORE WET WEATHER CONSENT DECREE SMOKE AND DYED WATER TESTING FORM		Page 1 of 8
Sewershed: JONES FALLS	Company: REI/DRAYCO	Date: 07/23/08
Test to be Performed: SMOKE	Ground Condition: DRY	Supervisor: ER
Manhole ID: S35MM_057MH	Test ID: 0994-365	Notifications Made: <u>X</u> (Residents, Fire, 311)
Field Sketch: (Show All Manholes with Numbers, Blower Placement Location, Sandbag or Isolation Locations, Street Names, Building Addresses and Locations, Defect Locations and Photograph Numbers)

CITY OF BALTIMORE
SMOKE TESTING OBSERVATION SUMMARY
JONES FALLS SEWERSHED
BALTIMORE CITY PROJECT 994
REI/DRAYCO

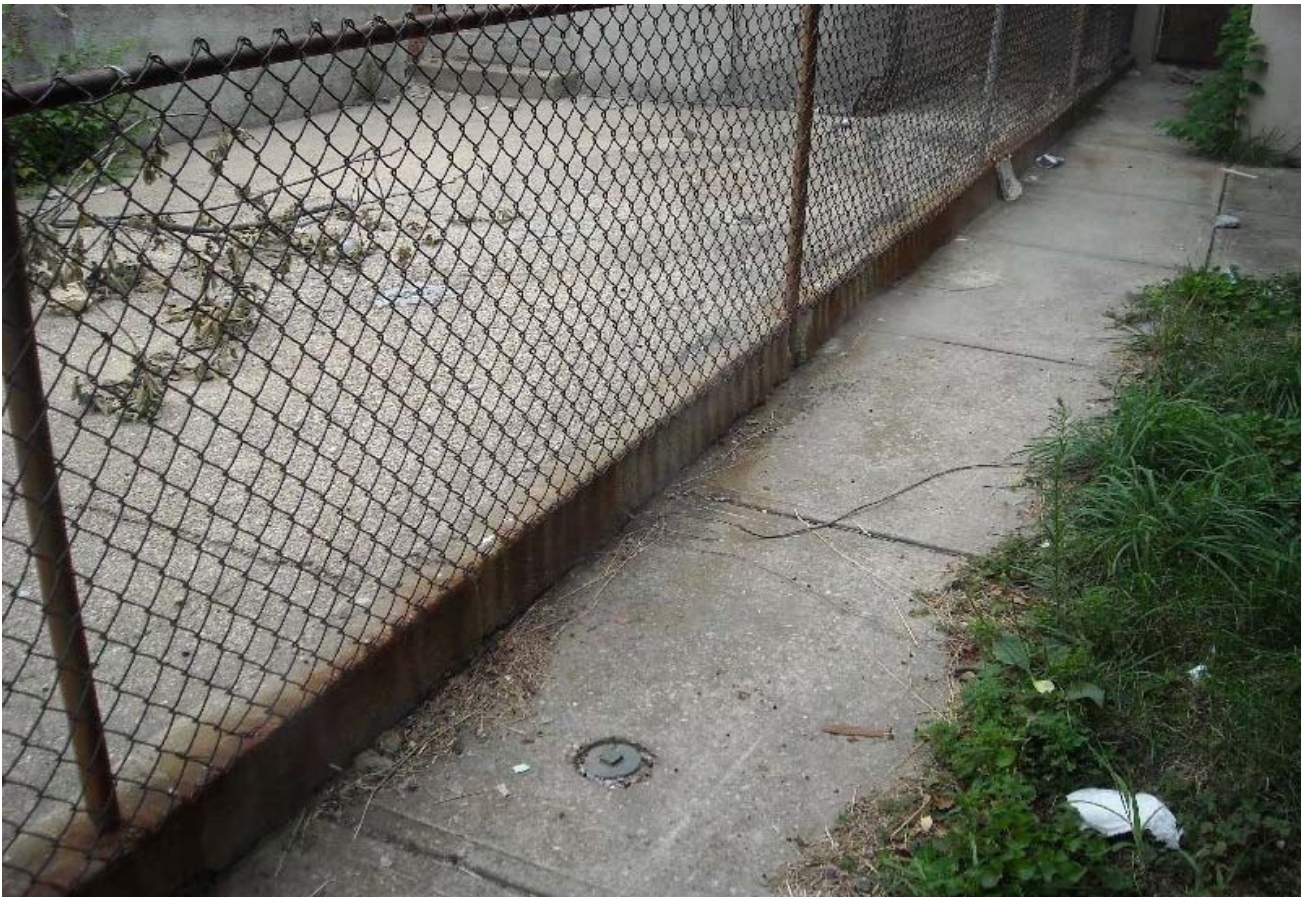
Photograph No: OB01-01
Filename: 0994-365_OB01-01.jpg

Unique Test ID: 365	Date: 07/23/2008	Basin: JF-19
Defect No: OB-01	Supervisor: E.R.	Dye Test Recommended: N
Address: 2004 BARCLAY ST.		
Source Type: 02	Location: 01	Severity: 03
Sector: 02	Drainage Area: 10	
Comments: SMOKE COMING FROM BELOW CONCRETE SLAB ALONG FENCE - NOTE THAT FENCE IS NO LONGER AT LOCATION

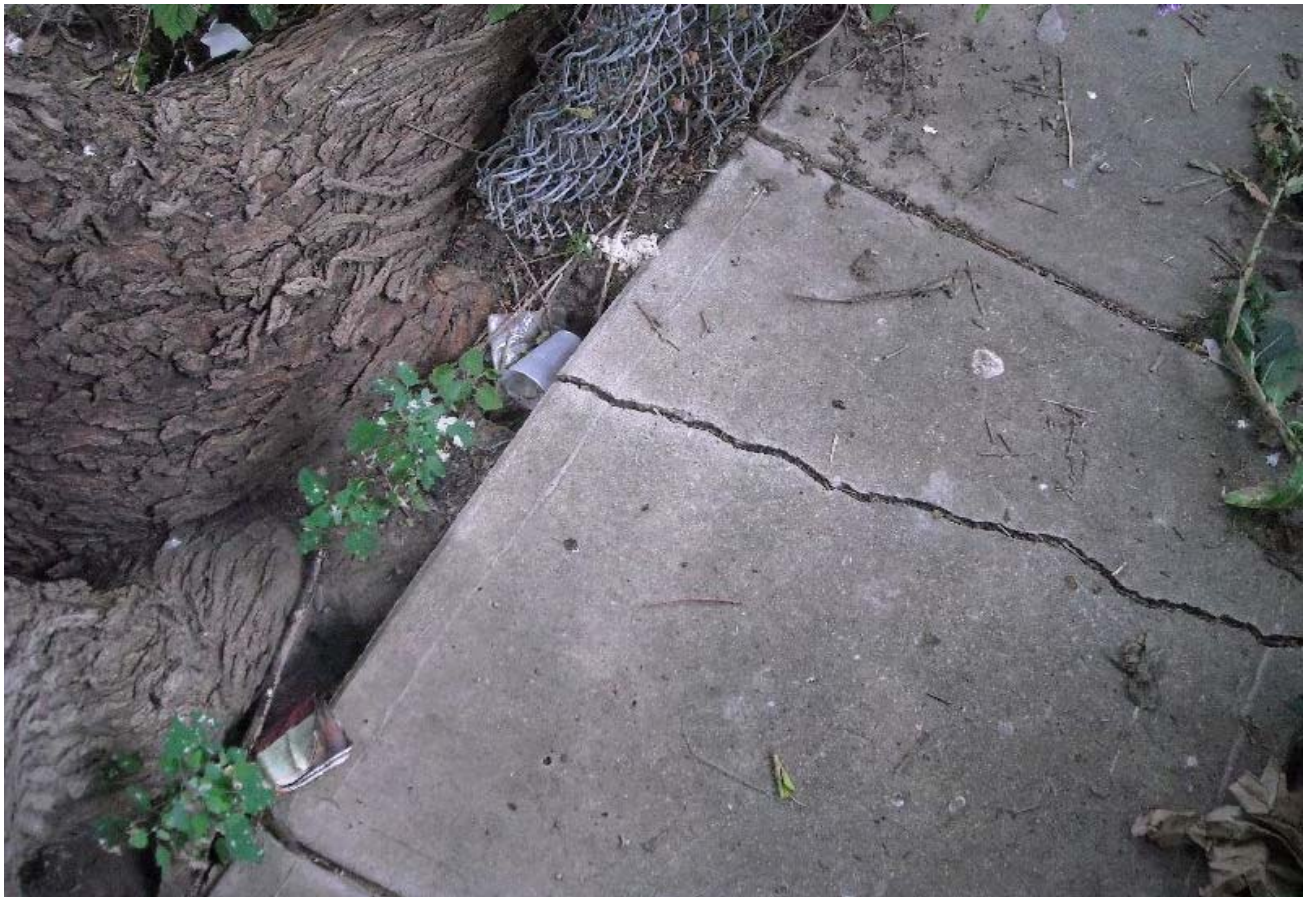
Photograph No: OB02-01
Filename: 0994-365_OB02-01.jpg

Unique Test ID: 365	Date: 07/23/2008	Basin: JF-19
Defect No: OB-02	Supervisor: E.R.	Dye Test Recommended: N
Address: 2012 BARCLAY ST.		
Source Type: 02	Location: 01	Severity: 02
Sector: 02	Drainage Area: 6	
Comments: SMOKE COMING FROM ALONG CRACK IN SIDEWALK

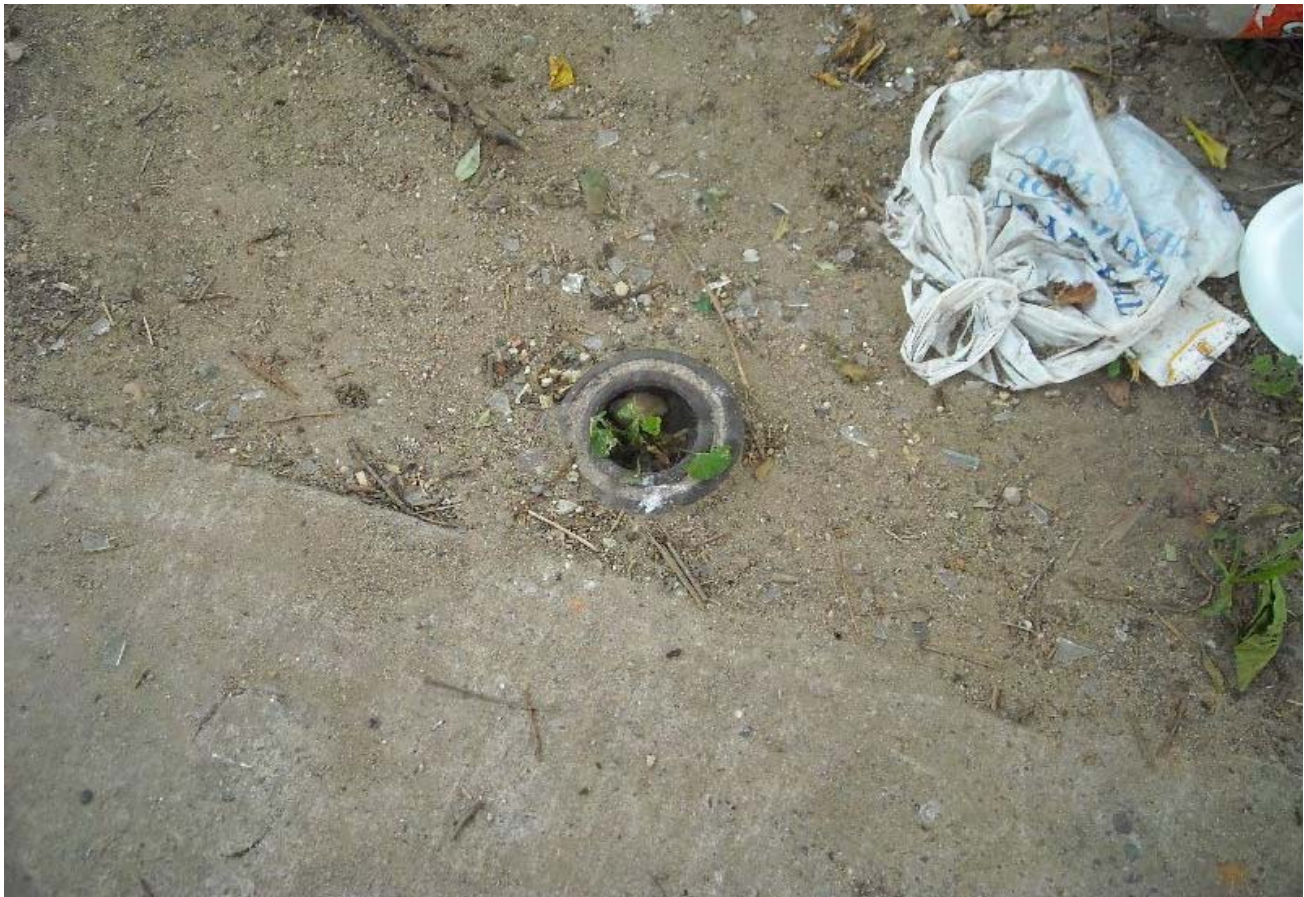
Photograph No: OB03-01
Filename: 0994-365_OB03-01.jpg

Unique Test ID: 365	Date: 07/23/2008	Basin: JF-19
Defect No: OB-03	Supervisor: E.R.	Dye Test Recommended: N
Address: 2014 BARCLAY ST.		
Source Type: 03	Location: 10	Severity: 02
Sector: 02	Drainage Area: 0	
Comments: CLEAN OUT - ABOVE GRADE - NO CAP

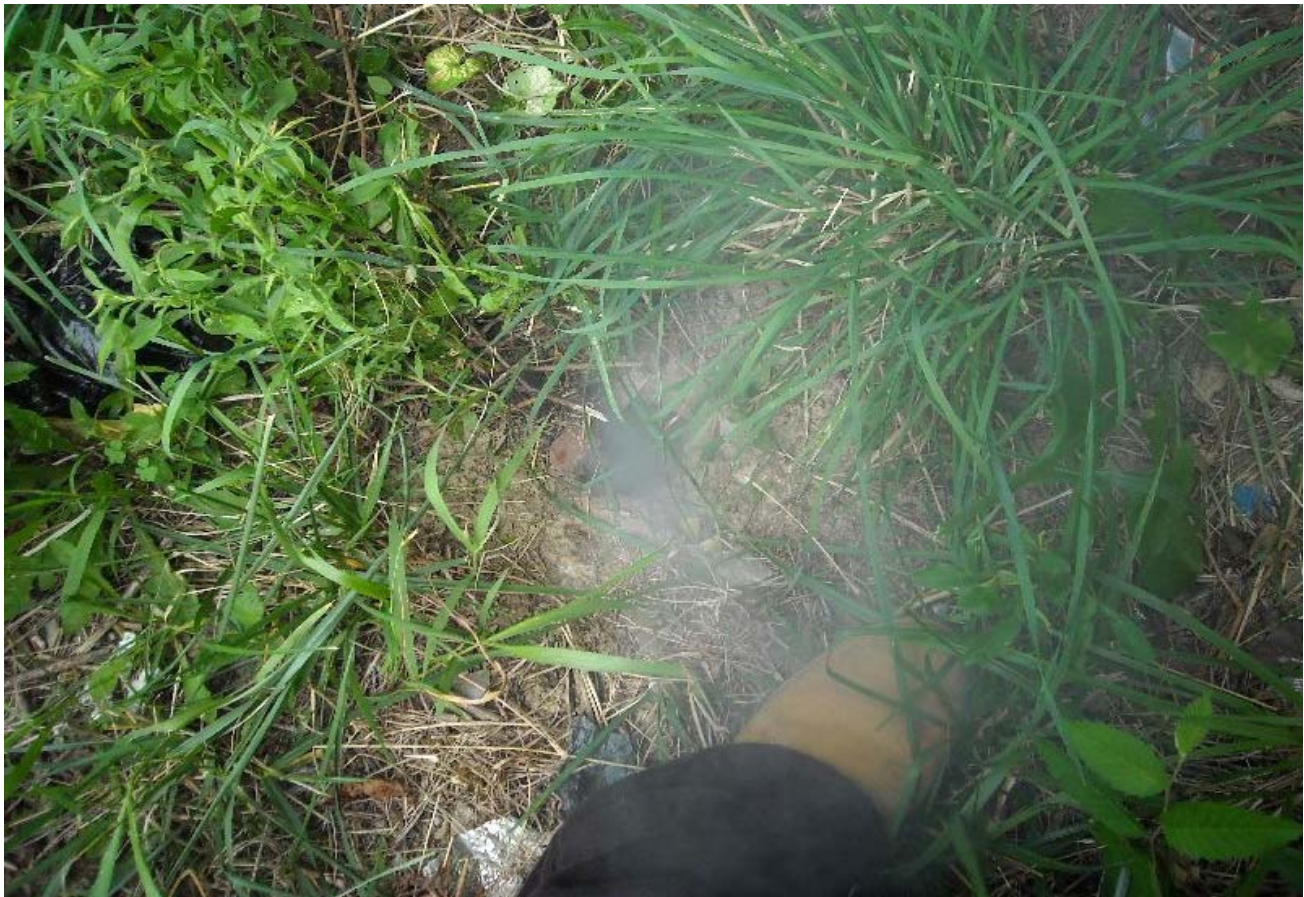
Photograph No: OB04-01
Filename: 0994-365_OB04-01.jpg

Unique Test ID: 365	Date: 07/23/2008	Basin: JF-19
Defect No: OB-04	Supervisor: E.R.	Dye Test Recommended: N
Address: 308 20TH ST.		
Source Type: 03	Location: 08	Severity: 03
Sector: 02	Drainage Area: 3	
Comments: CLEAN OUT - BELOW GRADE - MISSING CAP

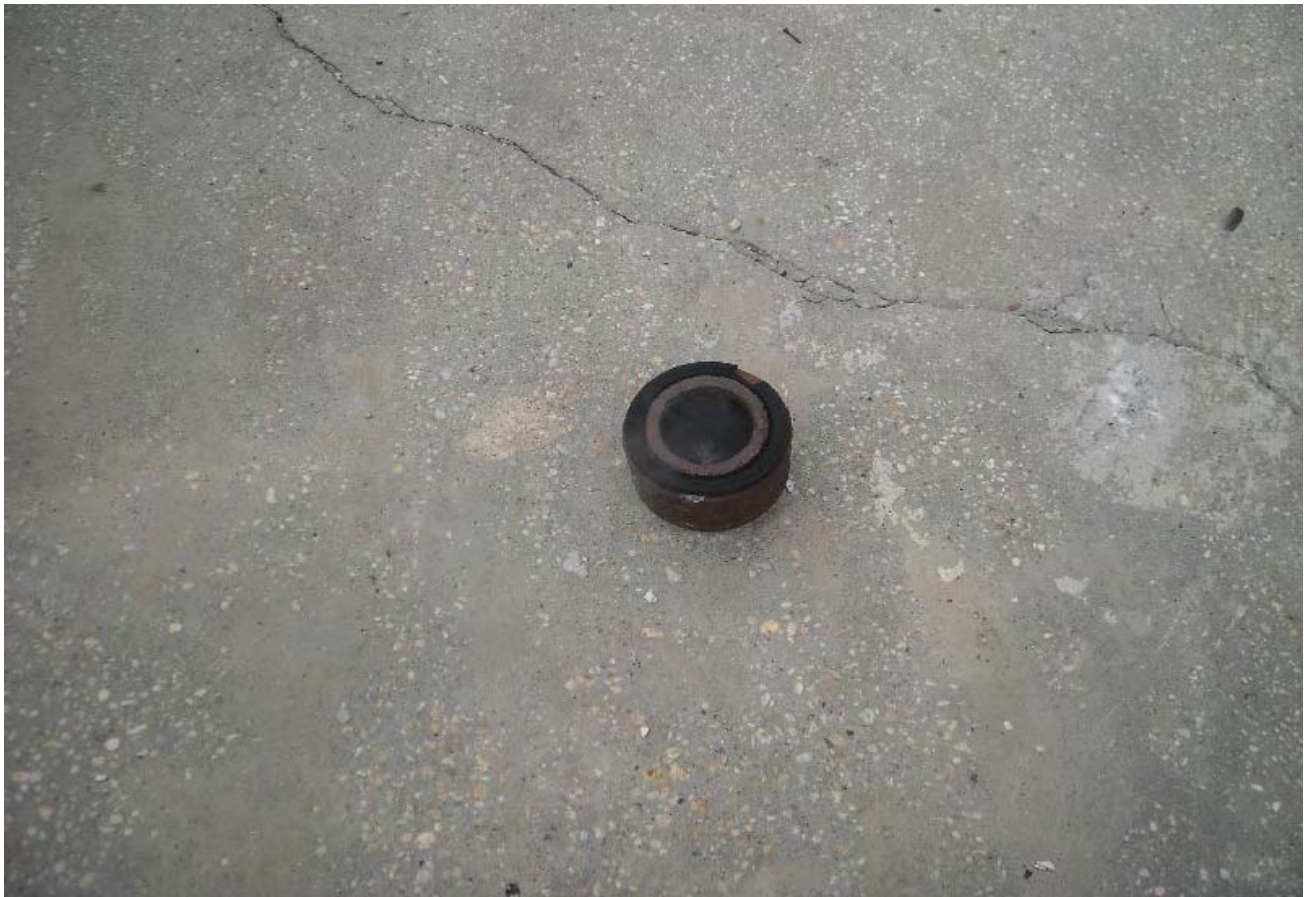
Photograph No: OB05-01
Filename: 0994-365_OB05-01.jpg

Unique Test ID: 365	Date: 07/23/2008	Basin: JF-19
Defect No: OB-05	Supervisor: E.R.	Dye Test Recommended: N
Address: 328 20TH ST.		
Source Type: 03	Location: 01	Severity: 02
Sector: 02	Drainage Area: 0	
Comments: CLEAN OUT - ABOVE GRADE - MISSING CAP

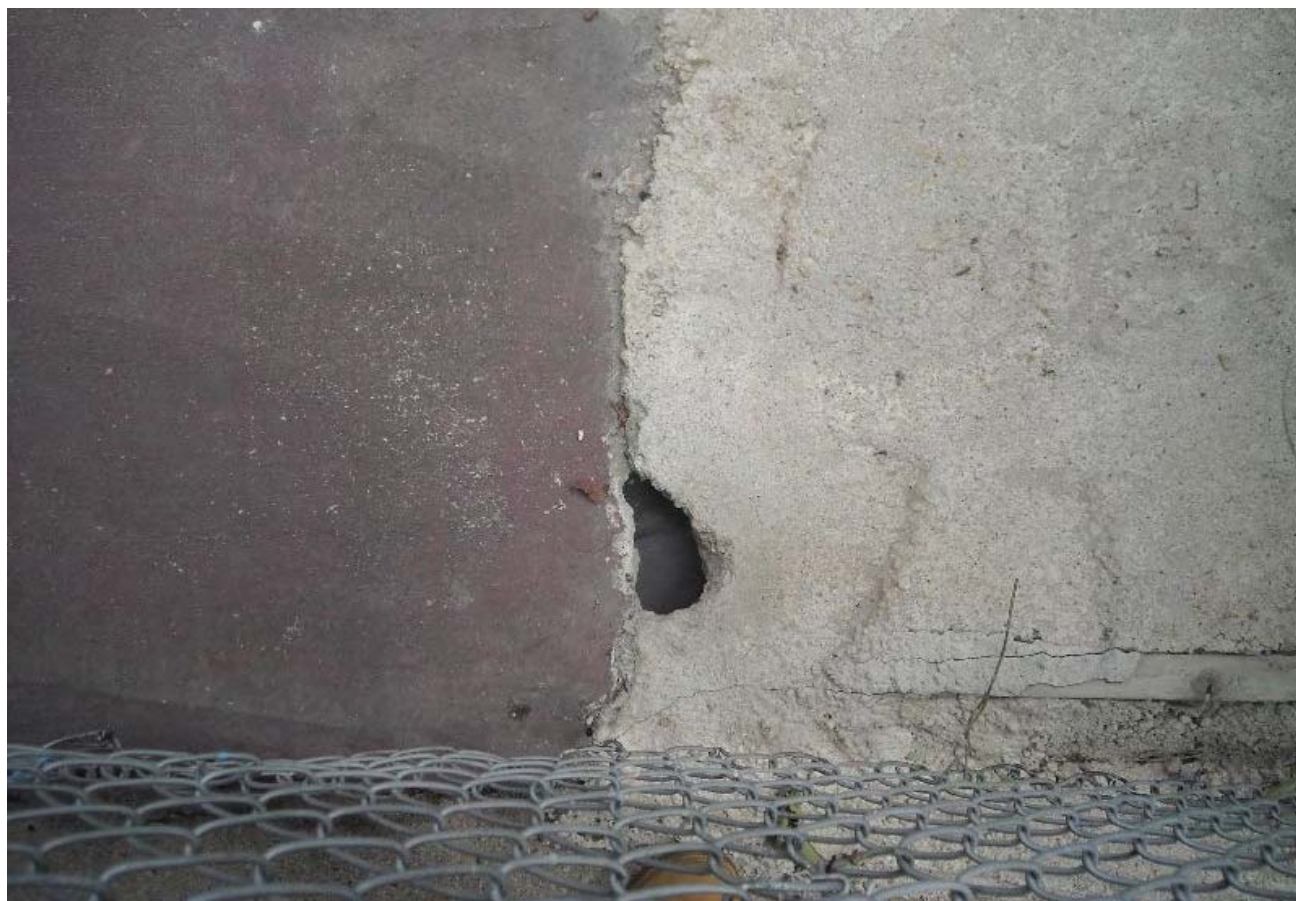
Photograph No: OB06-01
Filename: 0994-365_OB06-01.jpg

Unique Test ID: 365	Date: 07/23/2008	Basin: JF-19
Defect No: OB-06	Supervisor: E.R.	Dye Test Recommended: N
Address: 329 21ST ST.		
Source Type: 02	Location: 01	Severity: 02
Sector: 02	Drainage Area: 20	
Comments: SMOKE COMING FROM HOLE IN CONCRETE PATIO
